**N. W. Adams**  
Engineering Design Services

Annual Inspection (with maintenance) Report of Play areas at  
Easton, Couch Green, Martyr Worthy and Itchen Abbas Village Hall,  
for  
Itchen Valley Parish Council

21st May 2019

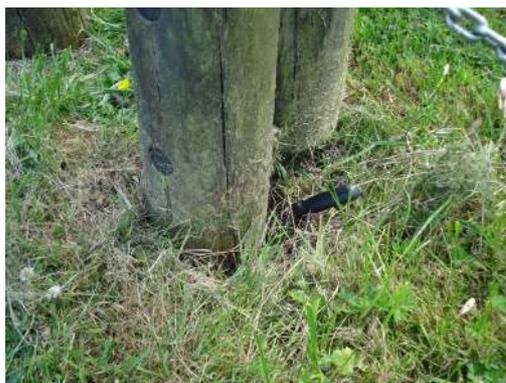
photo 2

Although not a definitive test, the posts were again probed just below ground level. Posts often decay internally & penetration (70mm maximum) was detected indicating that significant decay exists to the twin flexi-bridge post. *Programme to replace within 1 year to avoid collapse (photo 2).*

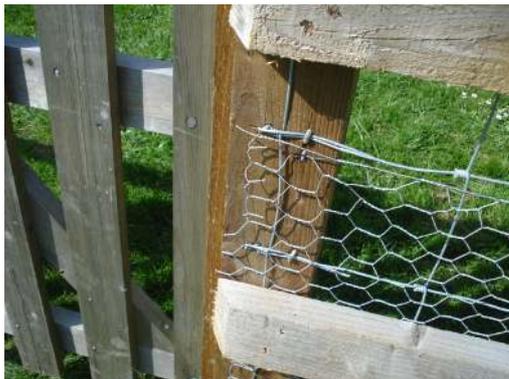
photo 3

Timber post & rail fencing with sheep/chicken mesh infilling to the lower section surrounding the play equipment.

*Trim/mask projecting chicken mesh wires at sides of both gates (photos 3 & 4).*

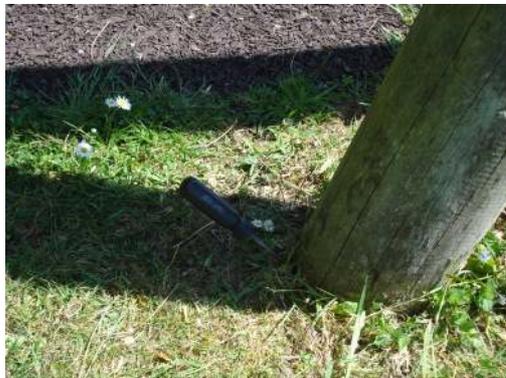
photo 6

Although not a definitive test, the posts were again probed just below ground level. Posts often decay internally & excessive penetration (100mm maximum) was detected indicating that significant decay exists to the twin flexi-bridge post. *Programme to replace decayed posts within 3 months recommended (photo 6).*

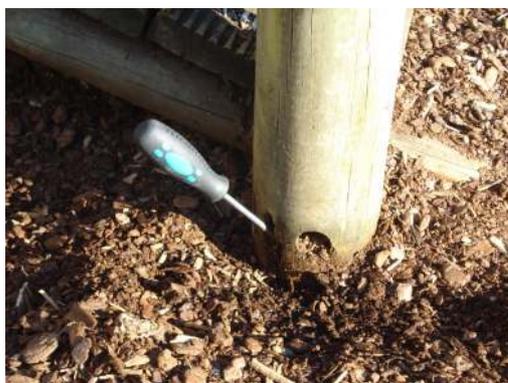
photo 12

Although not a definitive test, in view of the apparent age of the timber play equipment, the posts were probed just below ground level. Posts often decay internally and excessive penetration (100mm) was detected to the post at the ramp base & (150mm) to the corner post to the side of the sliding pole suggesting that decay exists. *Monitor & check at next Annual Inspection/programme/budget to replace (photo 12).*
